RE: Request for Information (“RFI”) Pursuant to Section 308 of the Clean Water Act  
K.A. Sunset View Farm, LLC Concentrated Animal Feeding Operation (“CAFO”)  
SPDES No. NYA001405  
Docket No. CWA-IR-15-030

Facility Name: K.A. Sunset View Farm, LLC

SPDES: NYA001405

**CAFO COMPLIANCE INSPECTION REPORT**

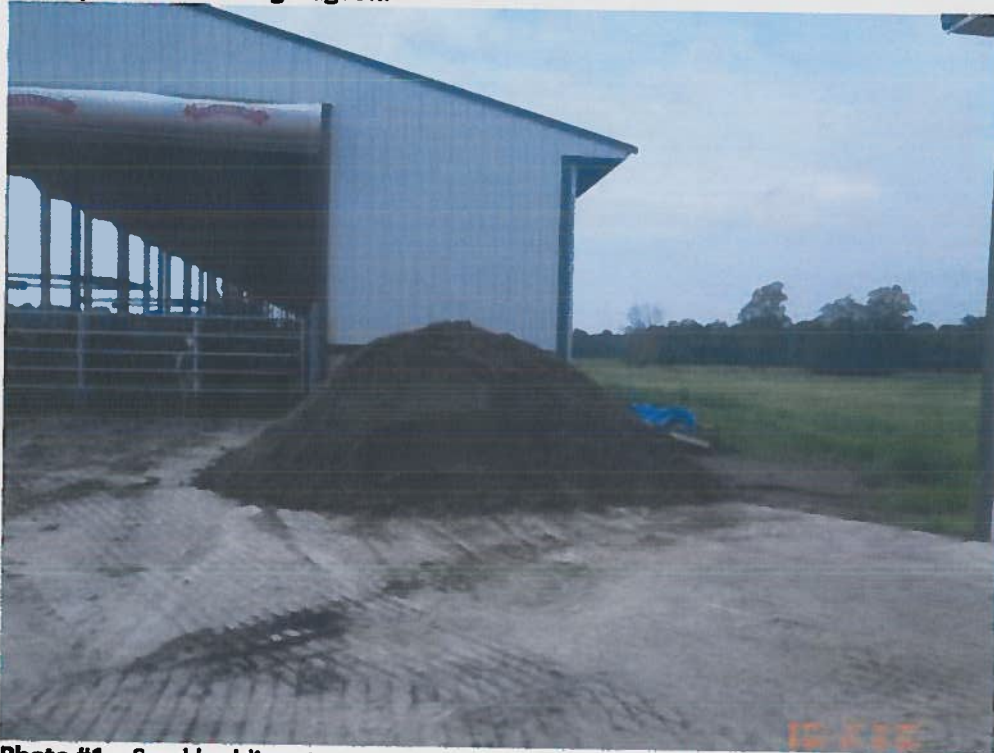
At the time of the inspection, EPA Inspector Arvizu observed storage of sand bedding at the east end of Barn #6. Runoff from the pile was observed in the adjacent grassy area. However, there are no waterbodies in the immediate vicinity. Mrs. Quinn stated that the runoff observed in the grassy area could potentially be from Barn #1 if they are unable to clean out the barn before solids build up, in addition to runoff from the sand bedding pile. The concrete pad is sloped in a way to drain runoff to the grassy area which is adjacent to the Facility's manure storage lagoon.

**Photo #1** – Sand bedding storage at east end Barn #6; note runoff in grassy field to right of barn and sloped concrete pad.

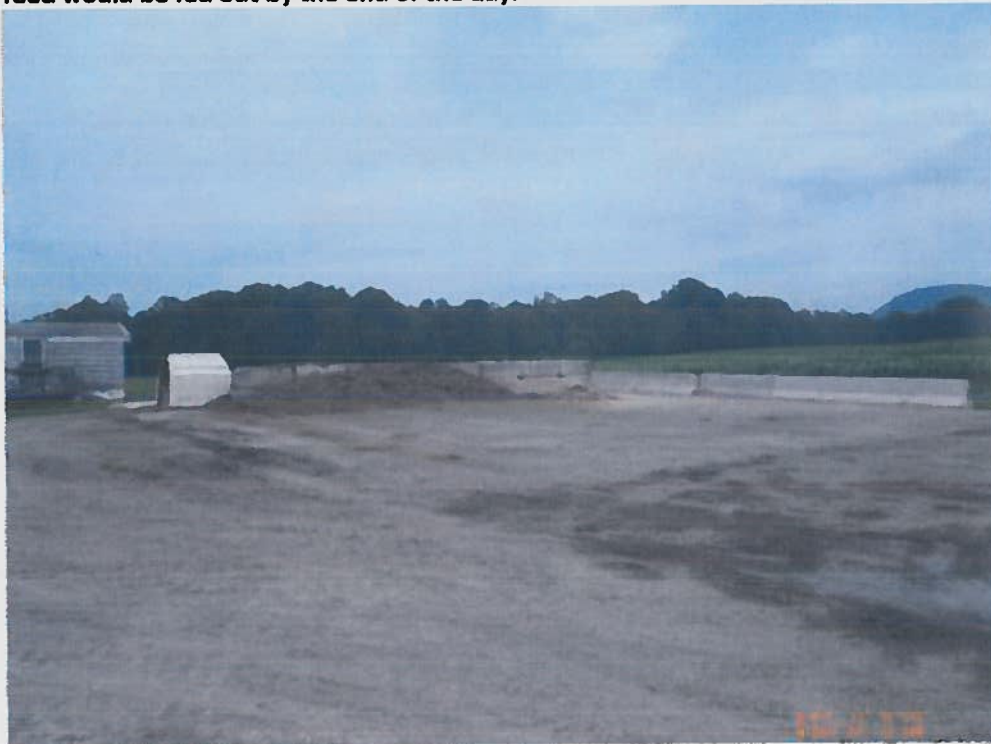
The Facility does not store feed on-site, as all feed (60 tons/day) is imported on a daily basis by Kernel Acres. Feed is trucked in to an uncovered feed drop off area northeast of Barns #4 & 5. At the time of the inspection, EPA Inspector Arvizu observed a ditch adjacent to, and east of, the feed drop off area. The ditch runs parallel to a neighboring crop field. EPA Inspector Arvizu did not observe leachate or impacts from leachate in the ditch as water in the ditch was clear and did not have an odor. In addition, at the time of the inspection, EPA Inspector Arvizu observed some feed on the concrete pad of the feed drop off area. Mrs. Quinn stated that the feed would be fed out by the end of the day.

**Photo #2 – Feed Drop off Area; view looking northeast. Ditch runs parallel to concrete knee wall and neighboring field.**

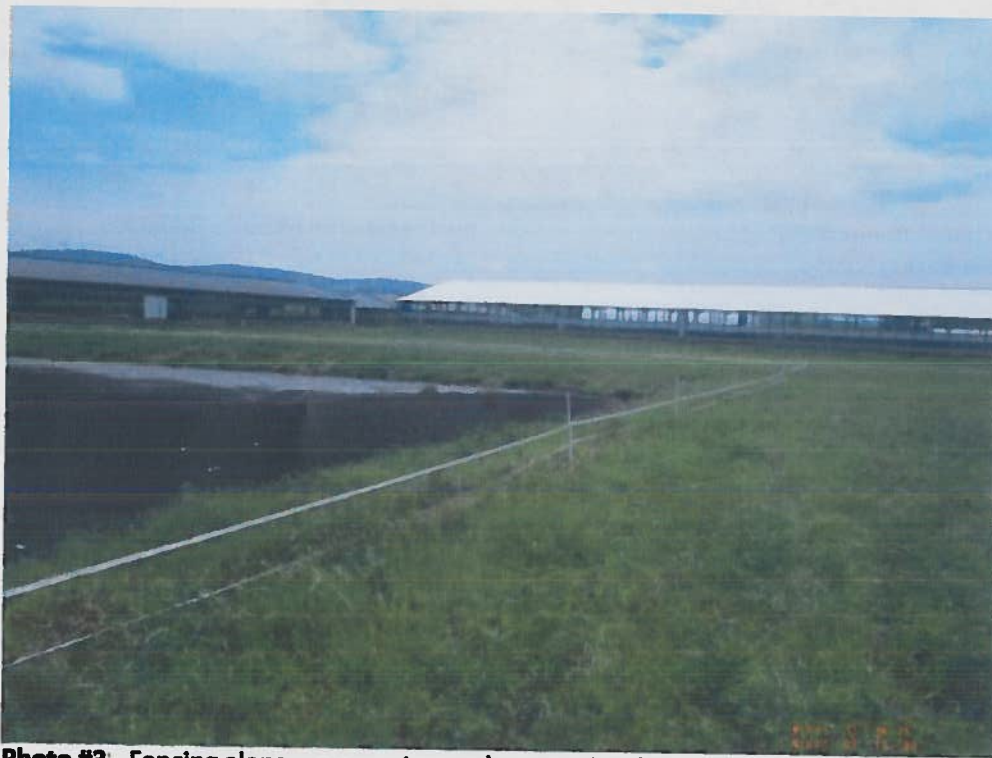
At the time of the inspection, Mrs. Quinn stated that the storage was approximately half full. EPA Inspector Arvizu observed a depth marker in the storage at the push-off ramp for Barn #2. In addition, EPA Inspector Arvizu observed that fencing surrounding the storage was not permanent. The existing fence consists of clothesline and 1" tape line that is strung on stakes.

**Photo #3 - Fencing along manure storage lagoon; view looking southeast with Barns 2 and 6 in background**

The adequacy of the fencing has been raised in previous NYSDEC inspection reports (June 16, 2010, July 27, 2009 and July 15, 2008). Specifically, NYSDEC stated that it questioned whether the fence “makes an effective physical barrier to ensure the safety of humans and livestock as required by USDA NRCS Conservation Practice Standard No. 313.” The inspector encouraged the Facility to consider installing a more substantial fence around the manure storage lagoon in each instance.

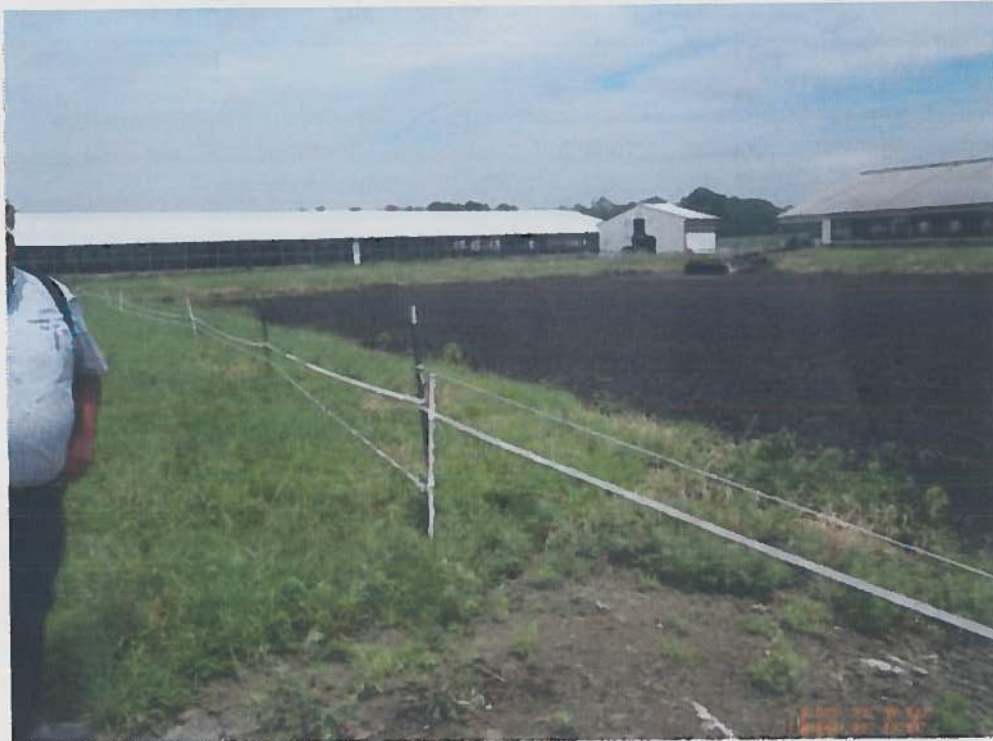
**Photo #4 - Close-up of fencing at manure storage lagoon; view looking northeast with Manure Separator Building and Barns 4 and 3 in background**

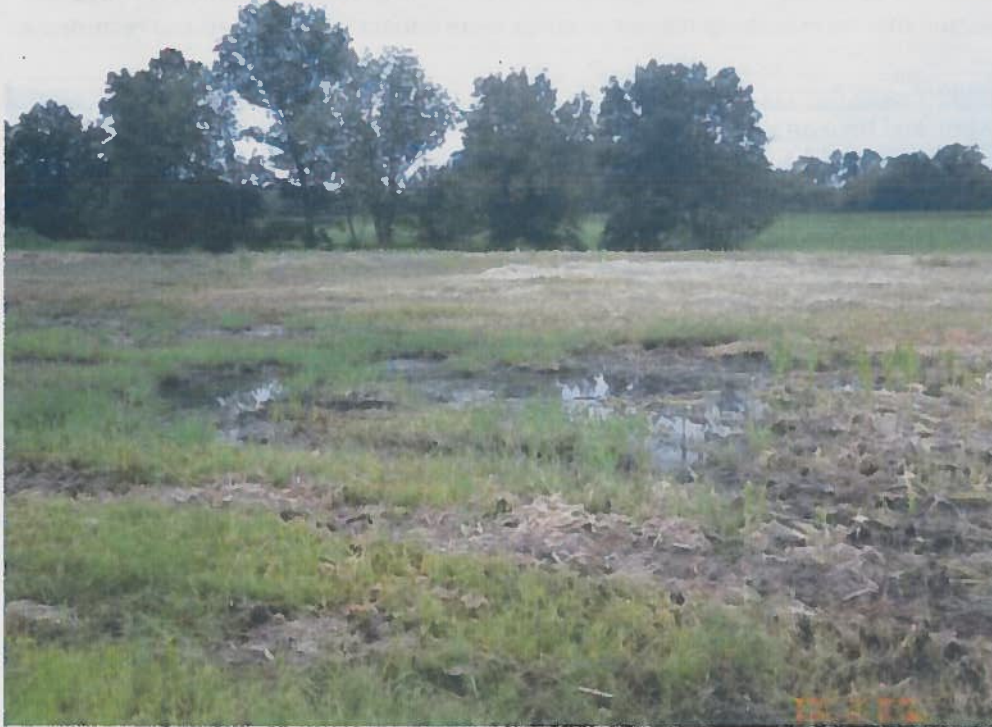
Section X.G of the NYSDEC CAFO General Permit requires that the permittee shall at all times properly operate and maintain all facilities and systems of treatment and control (and related appurtenances) which are installed or used to achieve compliance with the conditions of the permit. Washwater from the decontamination / wash shed and calf barns is directed to the filter strip / vegetated treatment area to the west of Calf Barn #1. At the time of the inspection, EPA Inspector Arvizu observed ponding in the upper third of the filter strip but no observed solids build-up. Beyond the end of the strip, there is a black corrugated pipe that outlets to the other side of a windbreak. No flow or impacts from the filter strip were observed in the pipe

or on the other side of the windbreak. Mrs. Quinn stated that the black pipe crosses under the driveway which leads to the manure storage and into her backyard. She also stated that there is no creek or stream in the vicinity.

**Photo #5 – Ponding in upper third of Calf Barn washwater filter strip; view looking south**
